MINIMIZING YAW BRAKE NOISE

Maintenance of wind turbine generators (WTGs) aims to sustain efficiency levels and ensure continued reliability, while also dealing with any other concerns that may be raised. One issue that is becoming more common is noise generated by the operation of the equipment in the nacelle, as opposed to any noise from the turbine blades. Svendborg Brakes has focused its expertise on yaw brake noise and developed a solution that can be applied to the majority of installations.

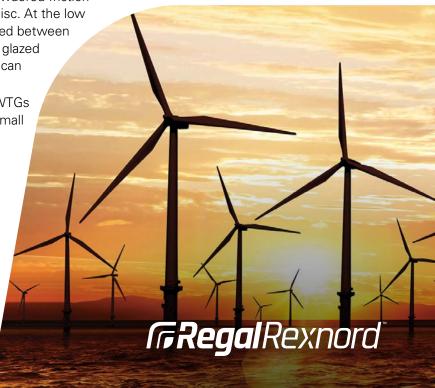
- Decades of Wind Energy focused innovation
- Cutting edge solutions to reduce yaw noise
- Specially shaped grooved brake discs significantly reduce noise
- Tool kits available for field retrofits

By cutting a specially shaped groove into the brake disc, it is possible to remove existing glazing and prevent it from occurring in the future. The groove does not increase brake pad wear significantly, but it does help to remove the build-up of powdered material in conjunction with a brush that is installed at the same time.

The testing resulted in a kit being created that would enable an engineer to install eight grooves in total – four on the upper surface and four on the lower surface of the brake disc. The kit includes the fixturing template to correctly align the groove on the disc. The process should take approximately three hours to complete one turbine.
